CHAPTER 2

NEW TEST SECTIONS

Five new test sections were constructed during the previous 2 years. The new test sections are:

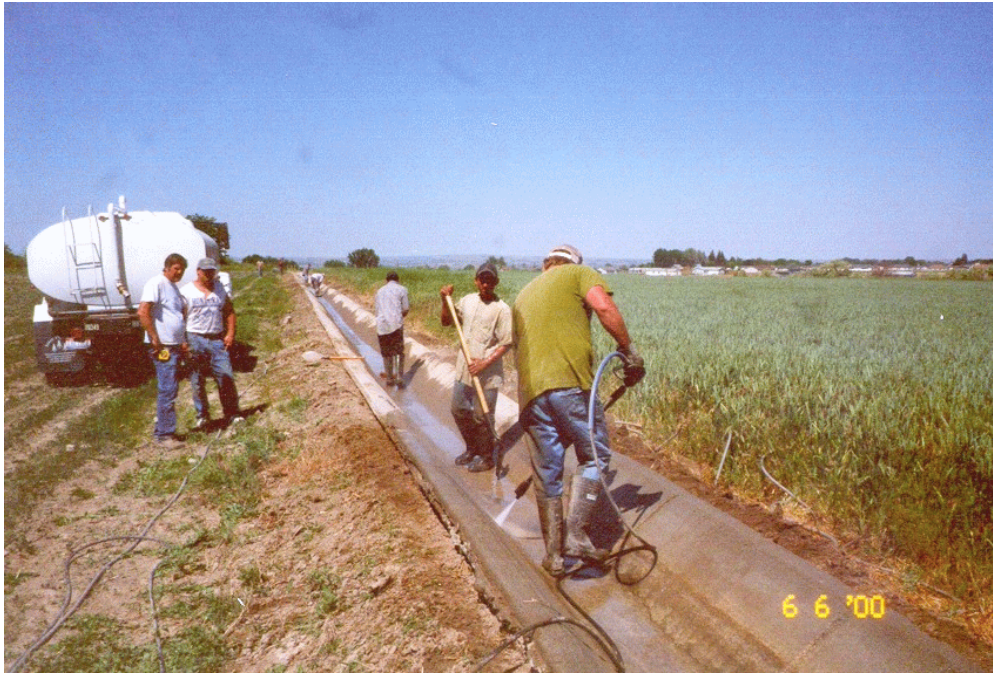
Photograph 3.—Power washing the ditch to remove dirt and sediment.

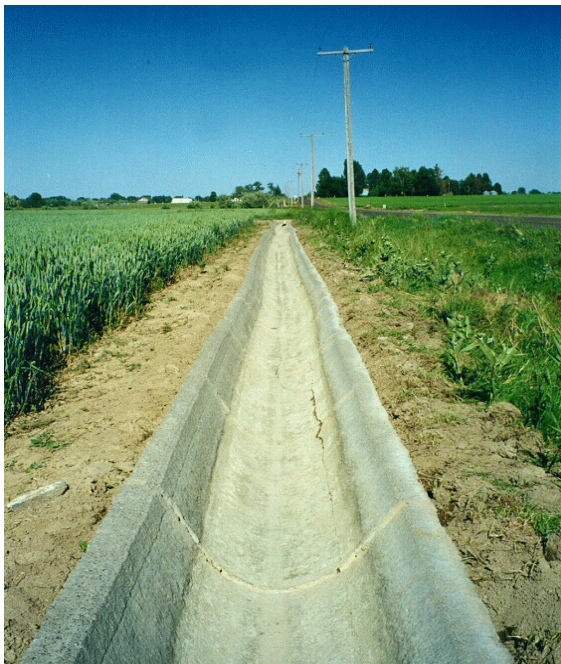
Photograph 4.—Ditch after power washing.
Subgrade preparation complete.

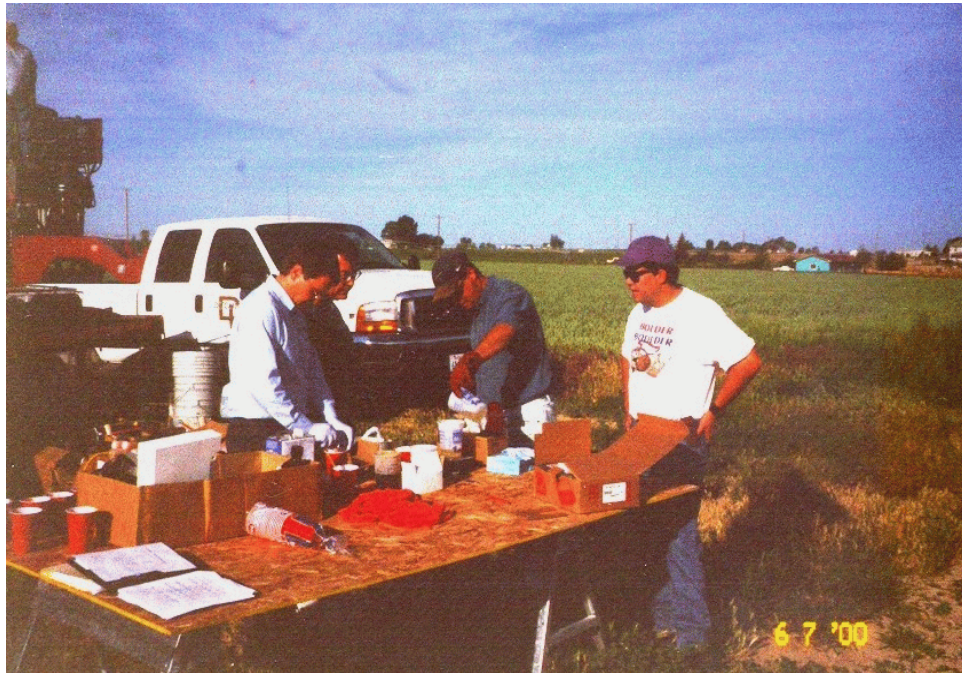
Photograph 7.—Before starting the job, chemists determine the proper mix ratios for Isocyanate, Polyol, and accelerator, depending on field conditions and temperatures.

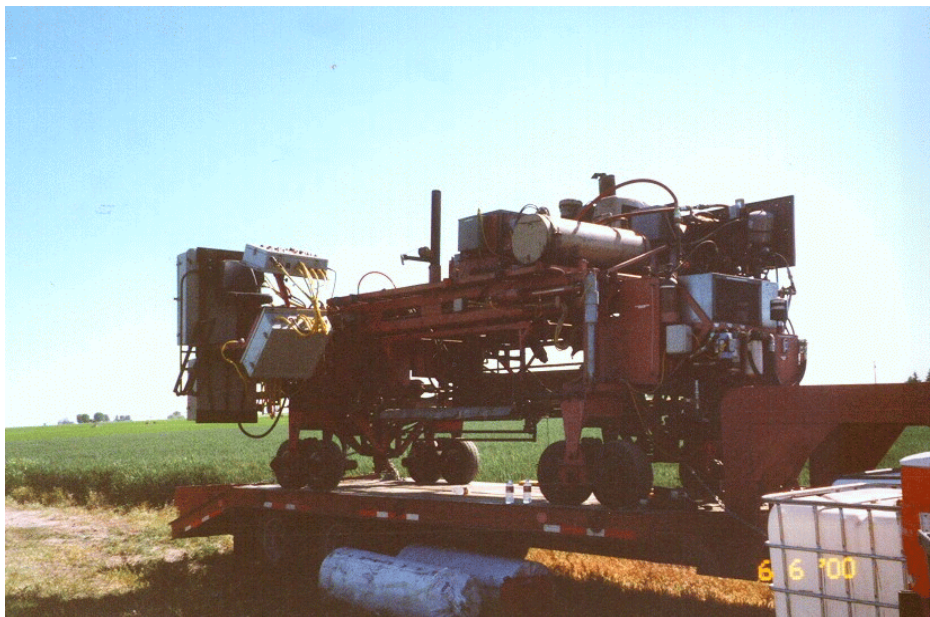
Photograph 8.—Lining machine on flatbed trailer.

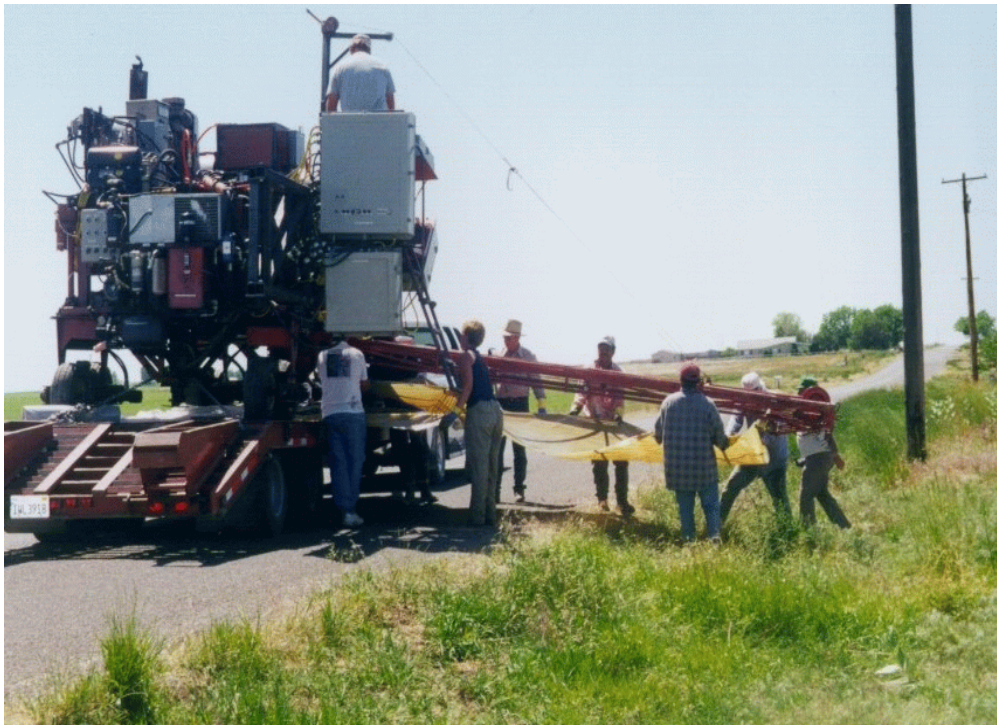
Photograph 10.—Lining machine produces a 6- by 16-foot panel every 1 to 2 minutes.

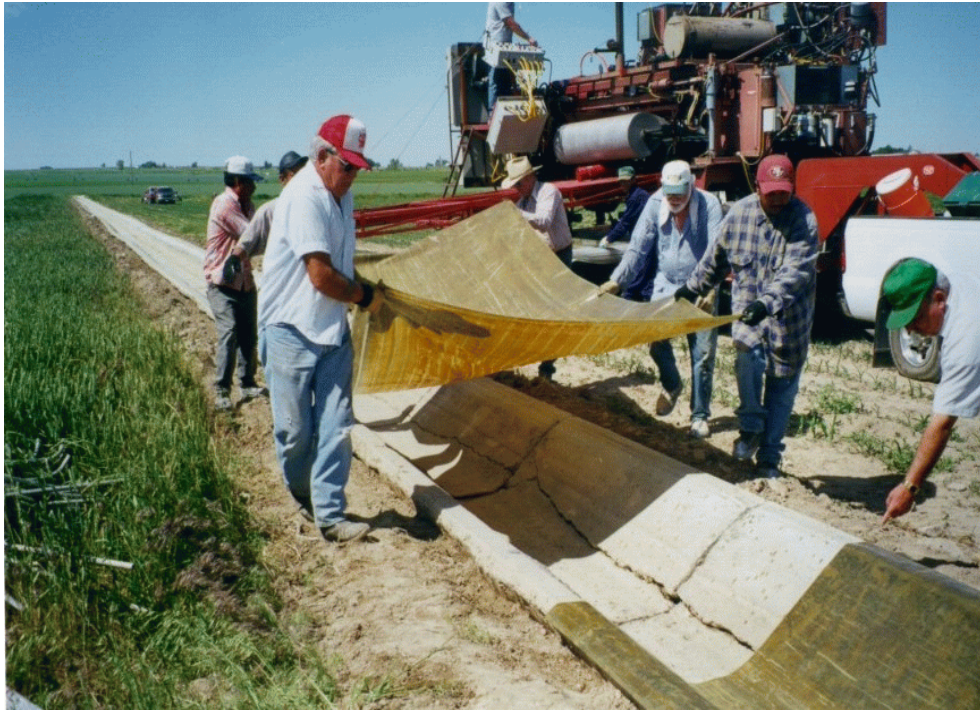
Photograph 11.—Crew lays the 6- by16-foot panel over the existing concrete.

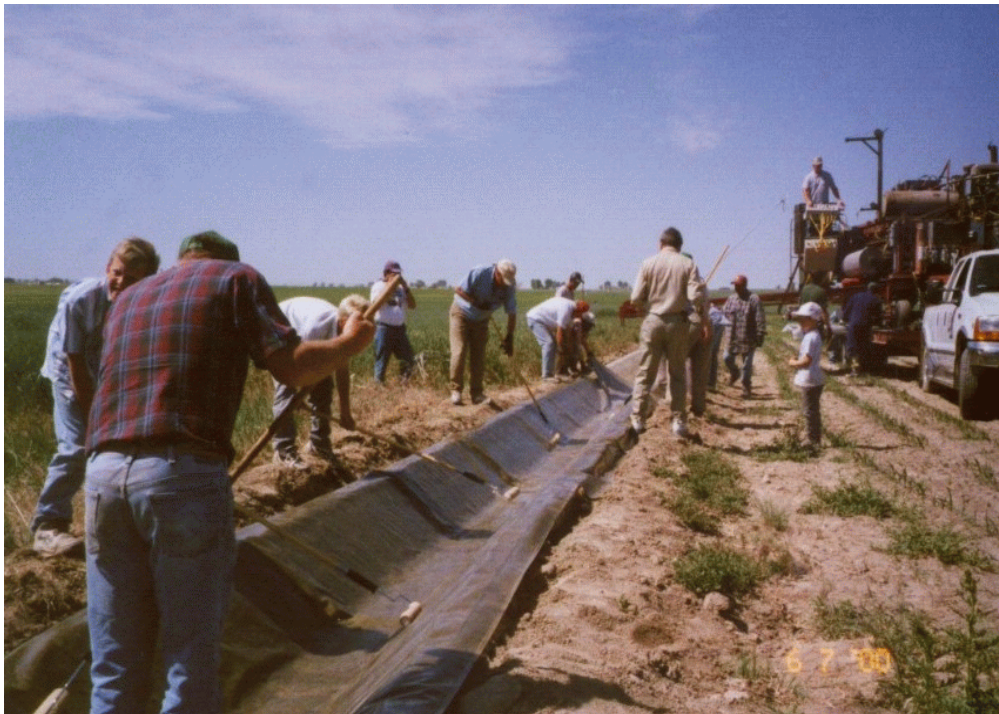
Photograph 12.—Laborers use rollers to work out wrinkles and improve adhesion to the concrete.

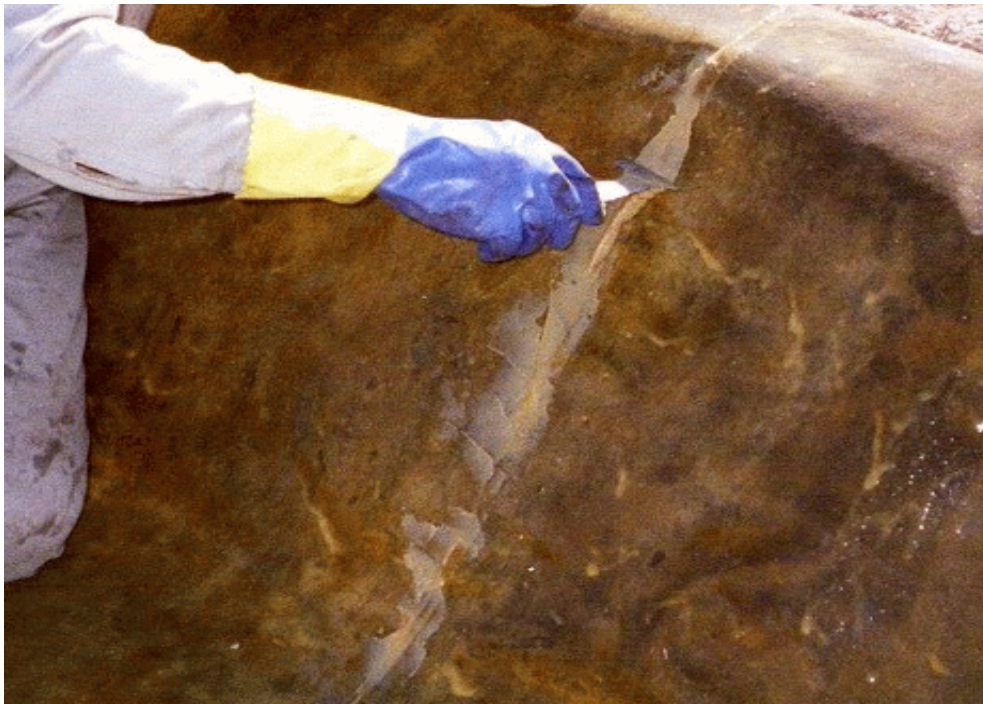
Photograph 16.—Chemist uses putty knife to trowel the patching compound.

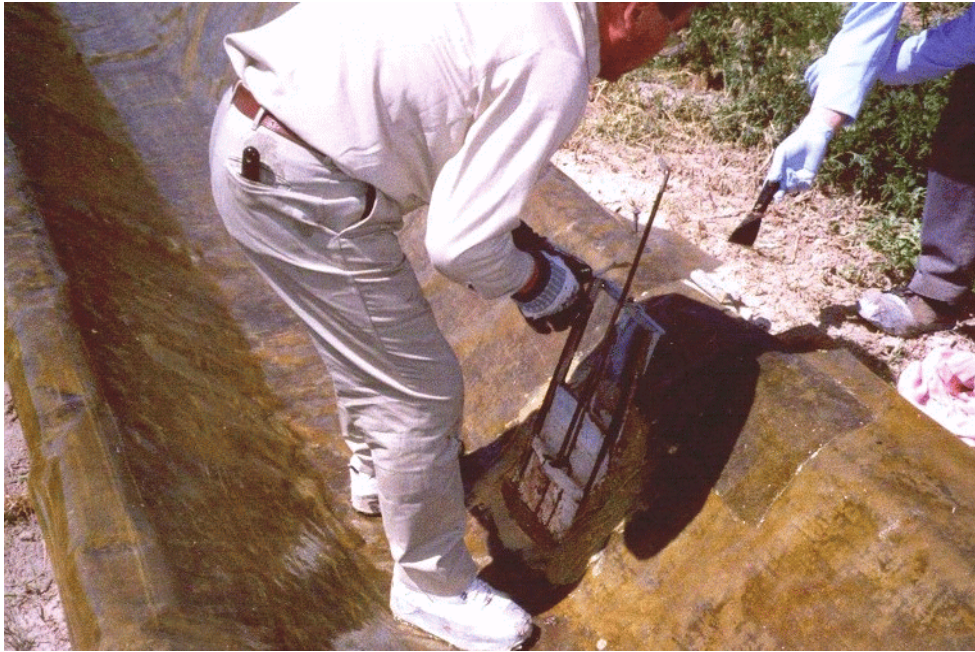
Photograph 17.—Patching compound was used to bond the liner around slide gate turnouts.

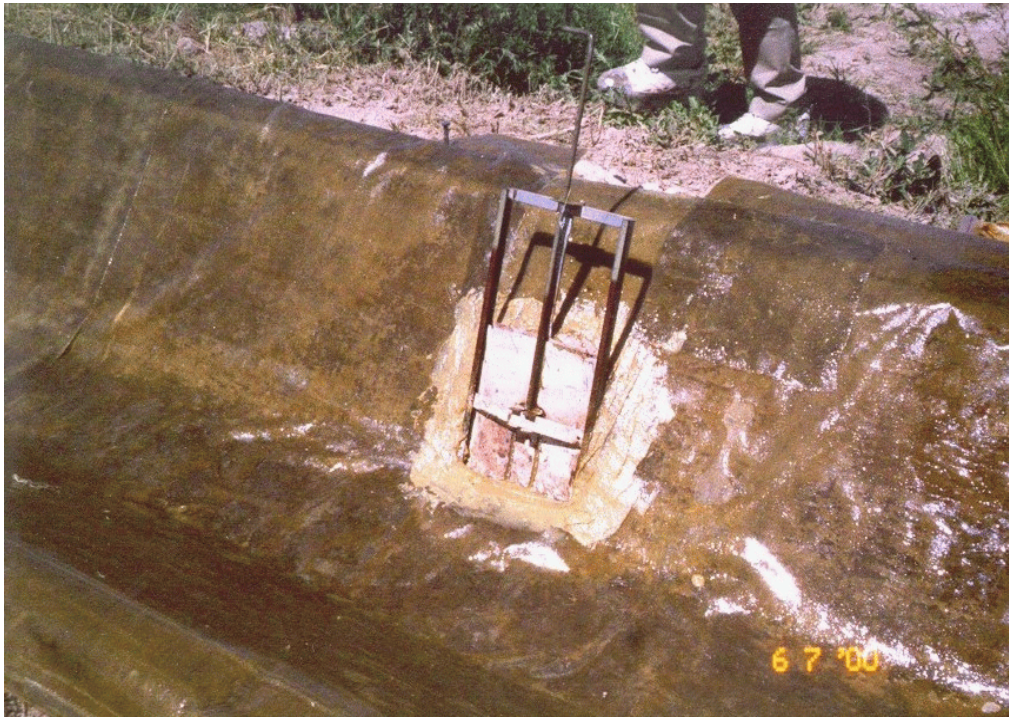
Photograph 18.—Slide gate turnout with patching compound.

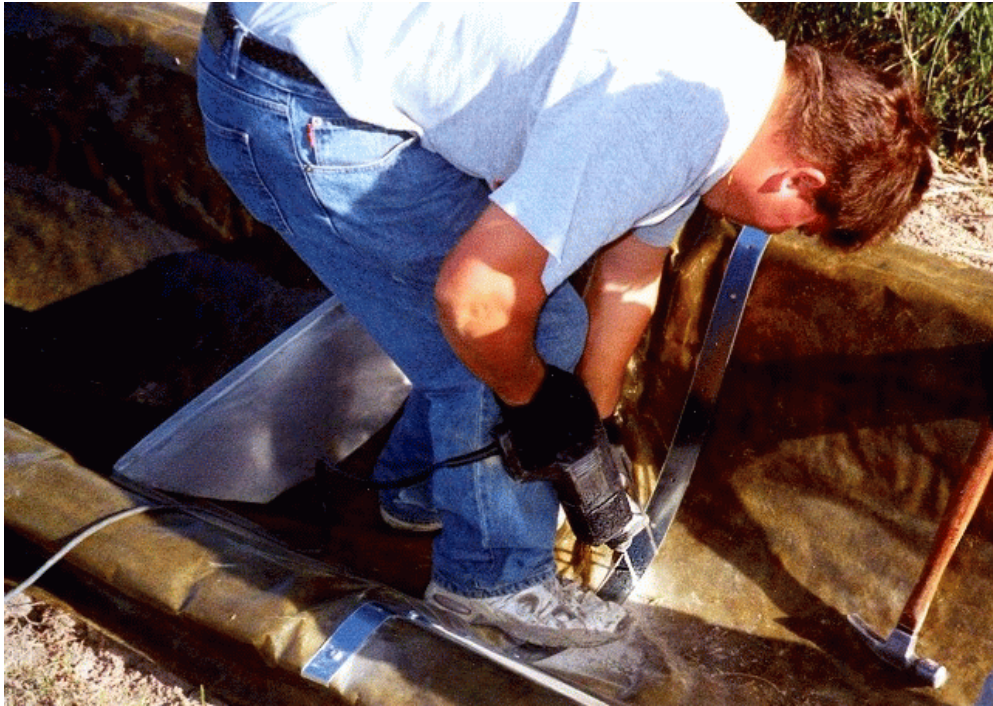
Photograph 19.—Batten strips were attached by pre-drilling holes and driving concrete anchors.

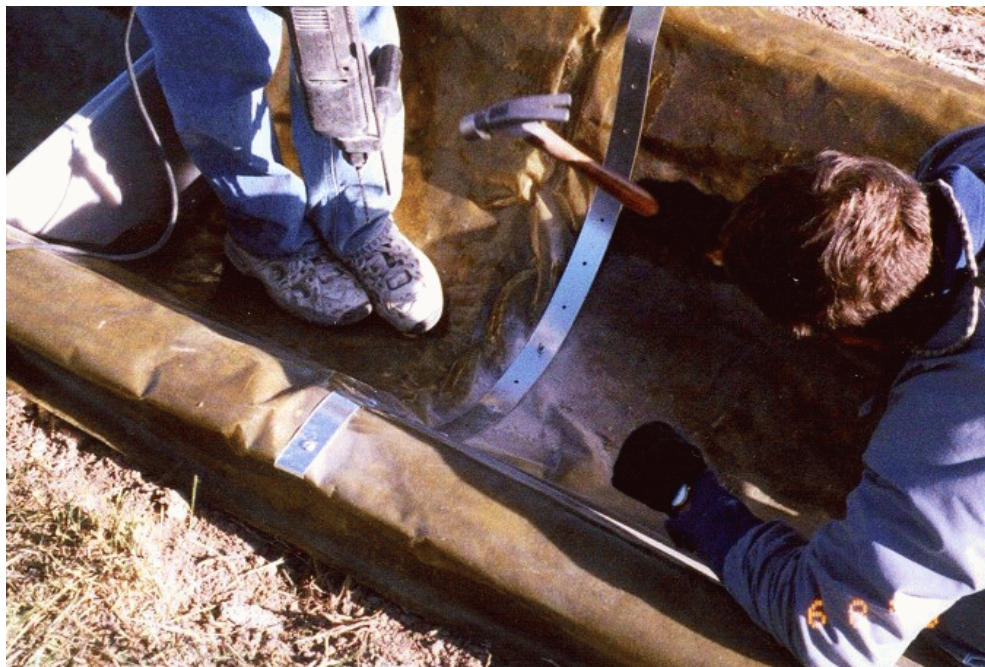
Photograph 20.—After pre-drilling, the 2-inch concrete anchors are easily hammered into the concrete. The 2-inch-wide batten strip is 16 gage stainless steel.

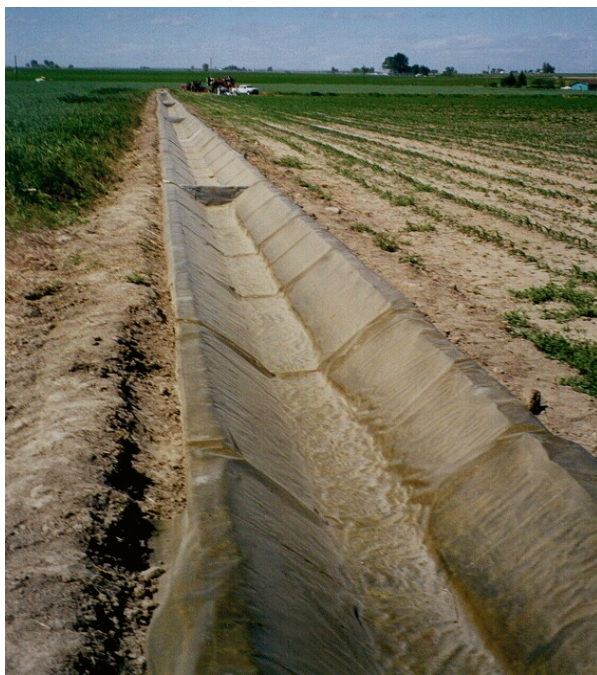
Photograph 22.—Ditch after installation was completed.

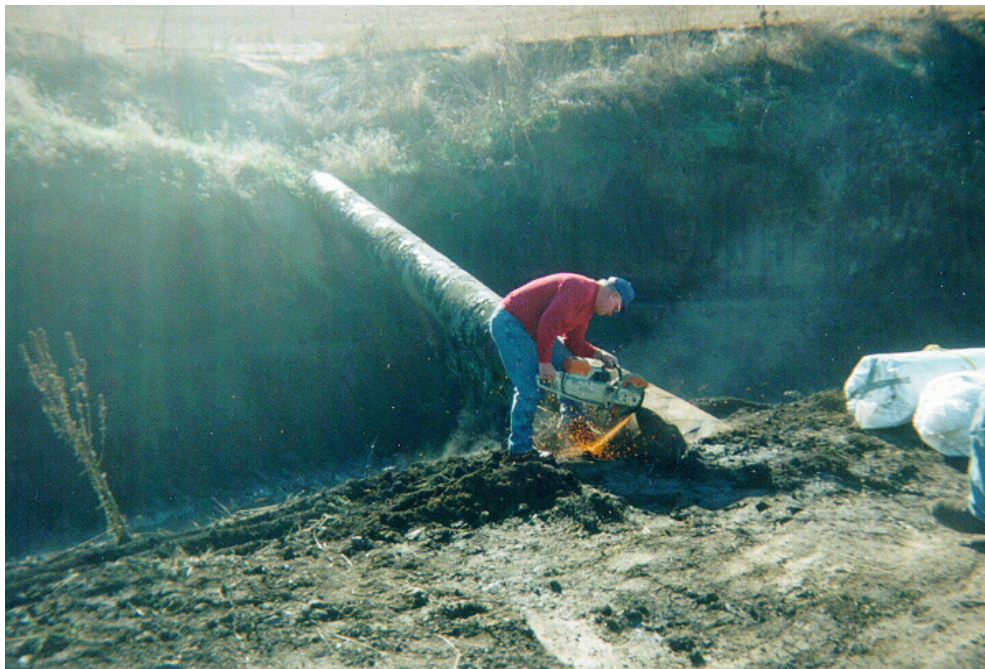
Photograph 2.—Irrigation district removed a couple of abandoned pipe crossings to
facilitate lining installation.

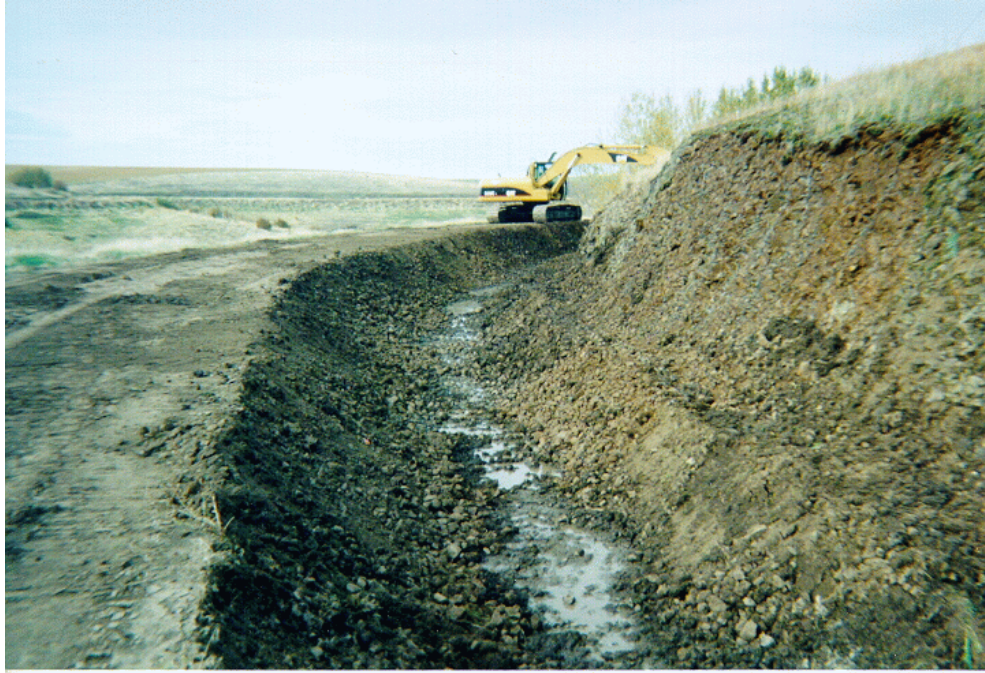
Photograph 3.—Trackhoe reshapes the canal prism, restoring the 1½:1 side slopes.

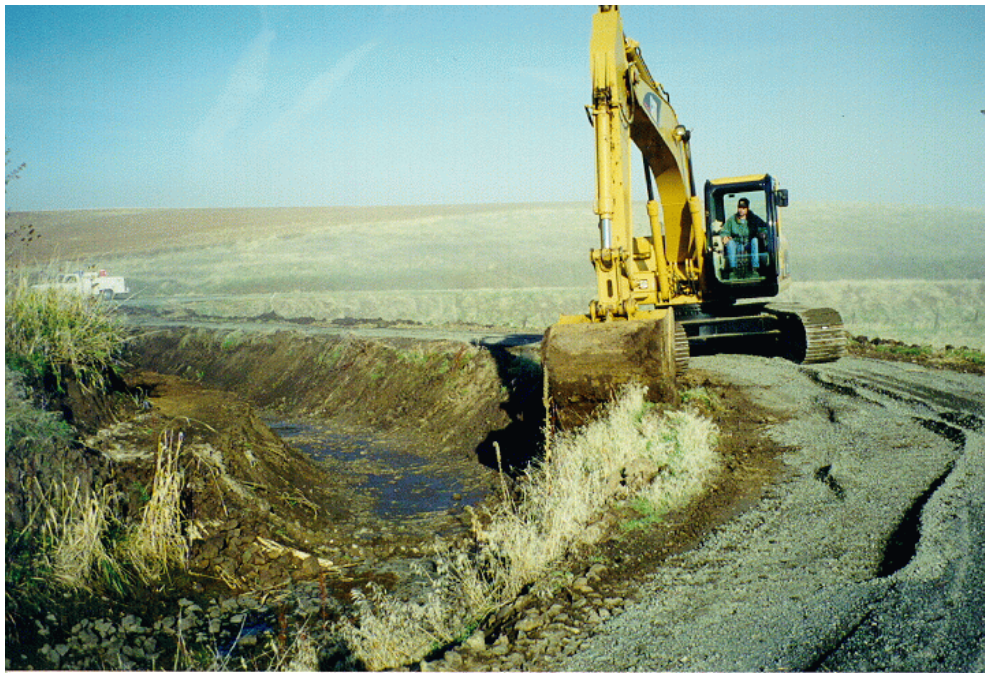
Photograph 4.—Trackhoe cuts 3-foot anchor berm into both banks.

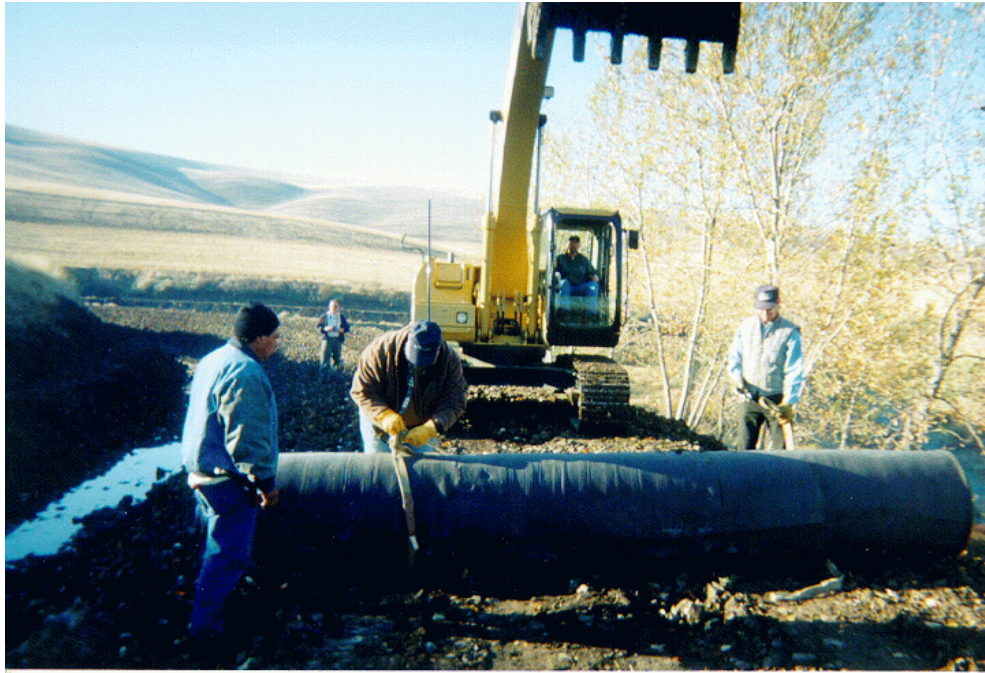
Photograph 5.—Trackhoe positions roll of geotextile cushion along the access road.

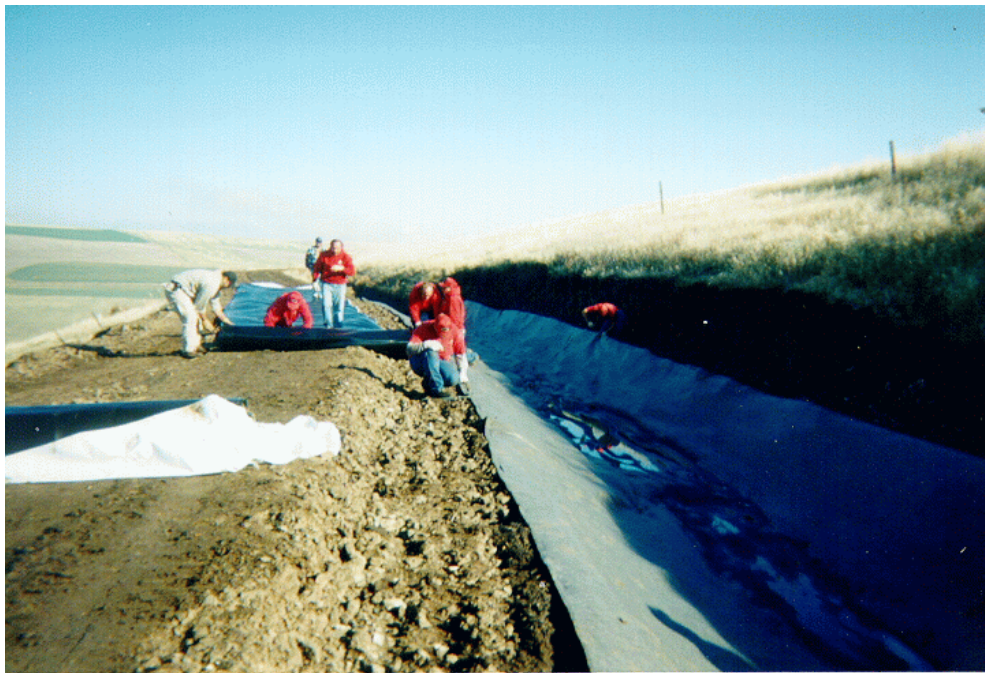
Photograph 6.—Geotextile cushion has been placed in the canal invert. The installation crew unrolls the Metallocene in the access road.

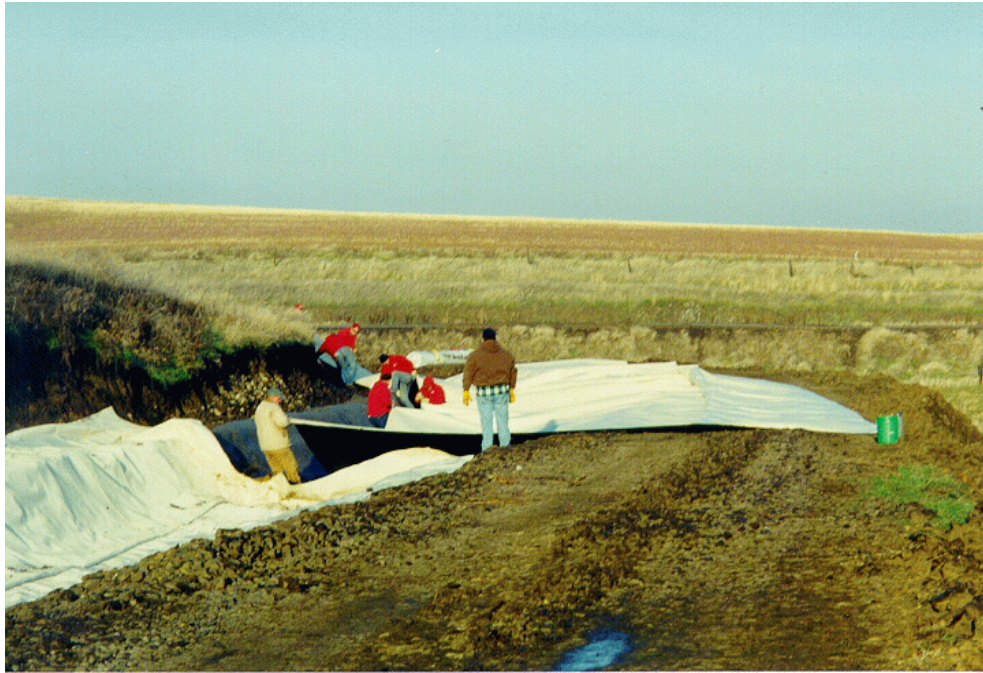
Photograph 7.—Crew unfolds the Metallocene and pulls the panel into place.

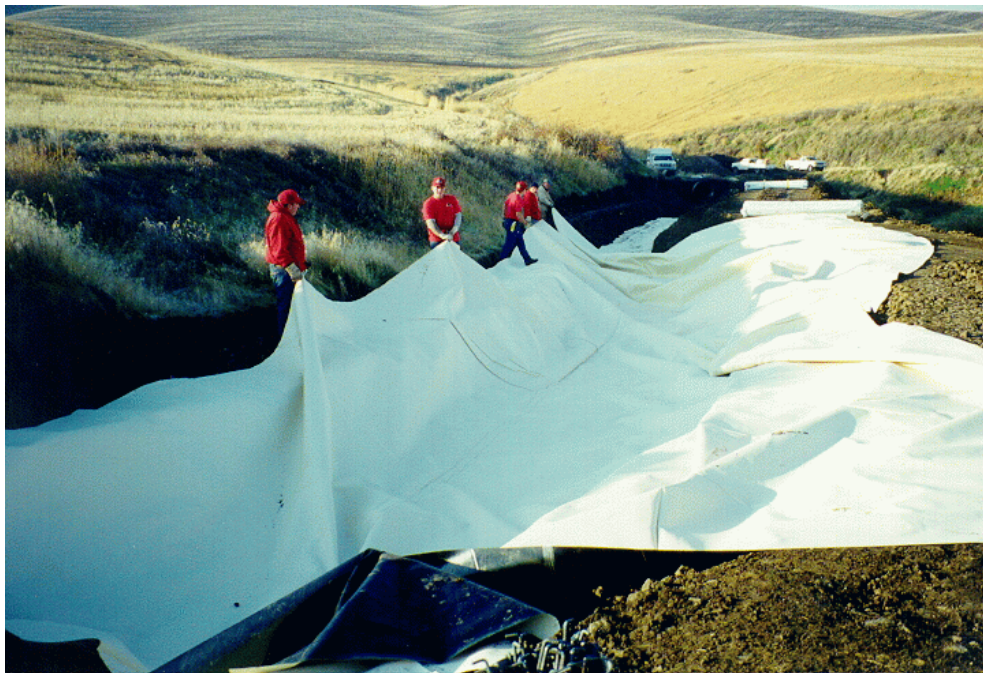
Photograph 8.—Installation crew pulls the Metallocene up the far bank and into final position.

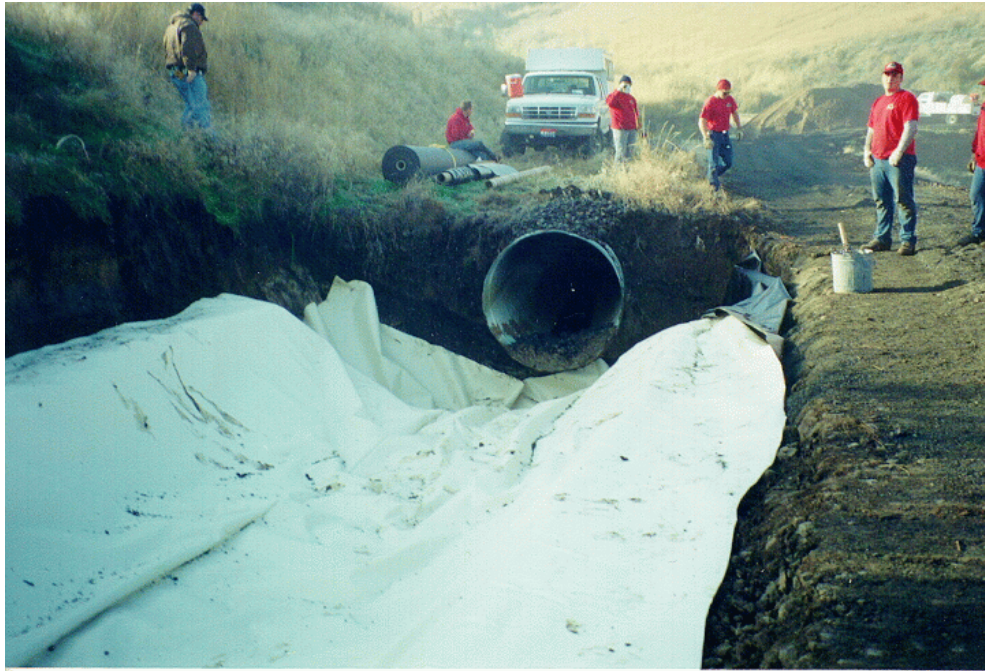
Photograph 9.—At the downstream end, the liner is placed into a 3-foot-deep cut-off trench.

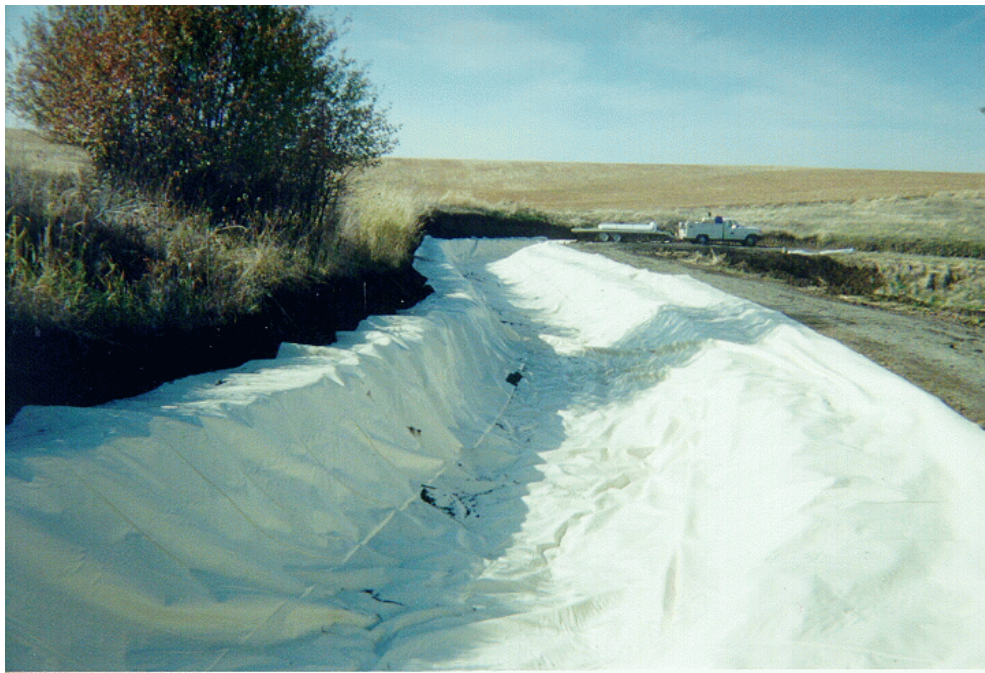
Photograph 10.—Liner is ready for seaming.

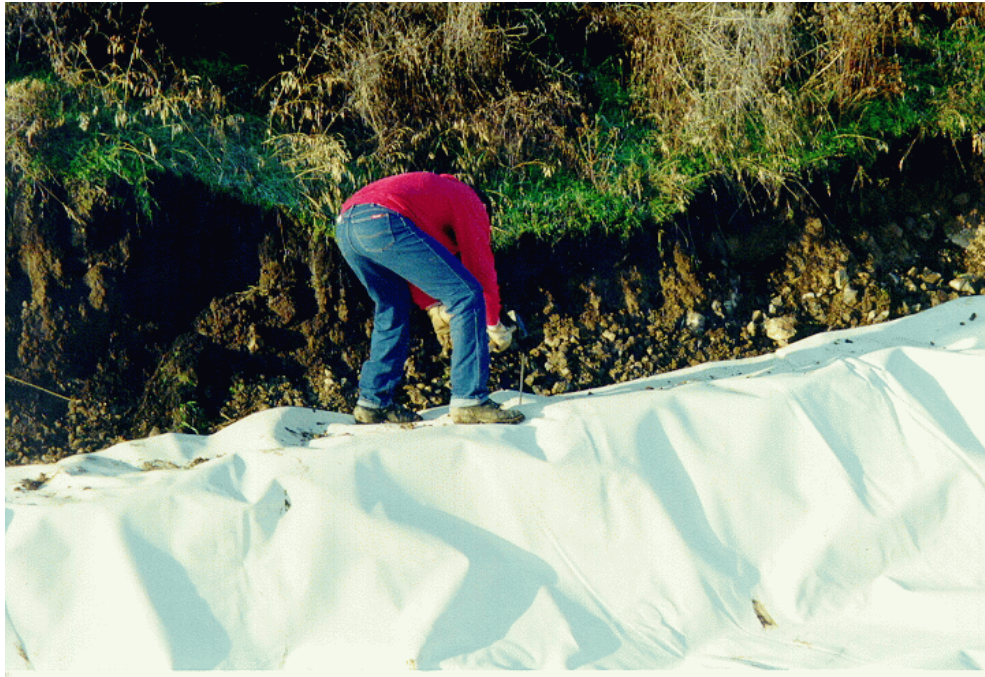
Photograph 11.—Liner is temporarily secured on the anchor berm with #3 rebar stakes.

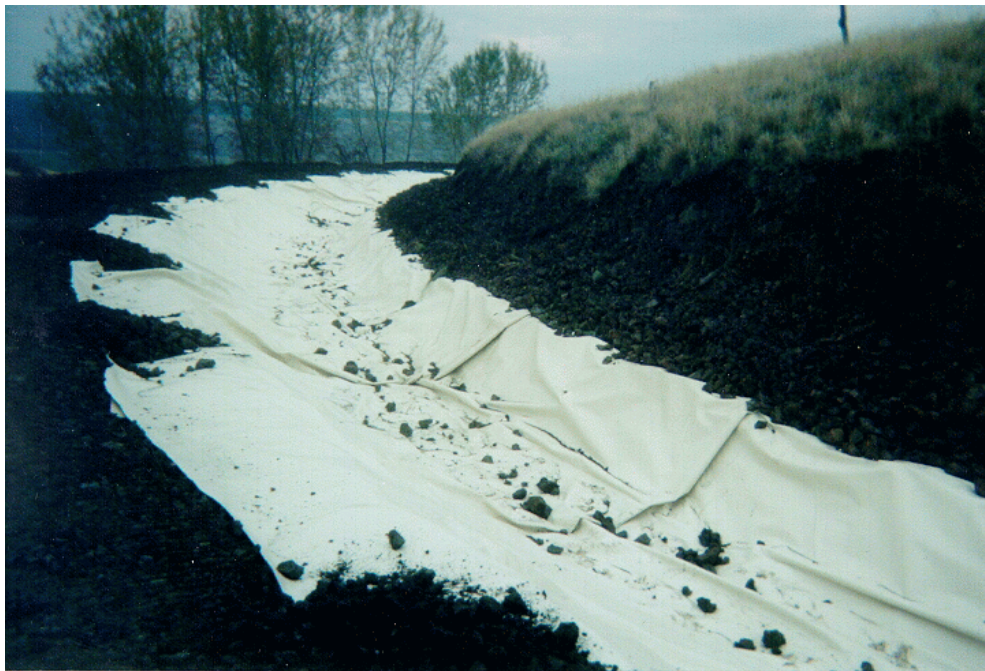
Photograph 12.—To minimize seaming, the liner was folded around bends in the canal alignment.

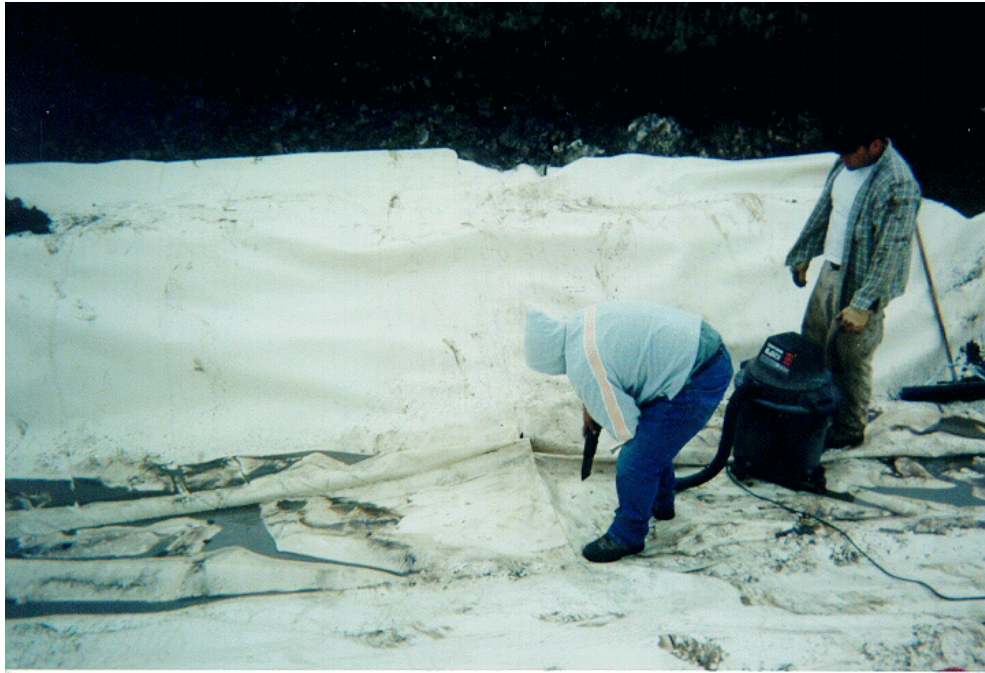
Photograph 13.—Wet-Dry Vac used to remove ponded water before seaming.

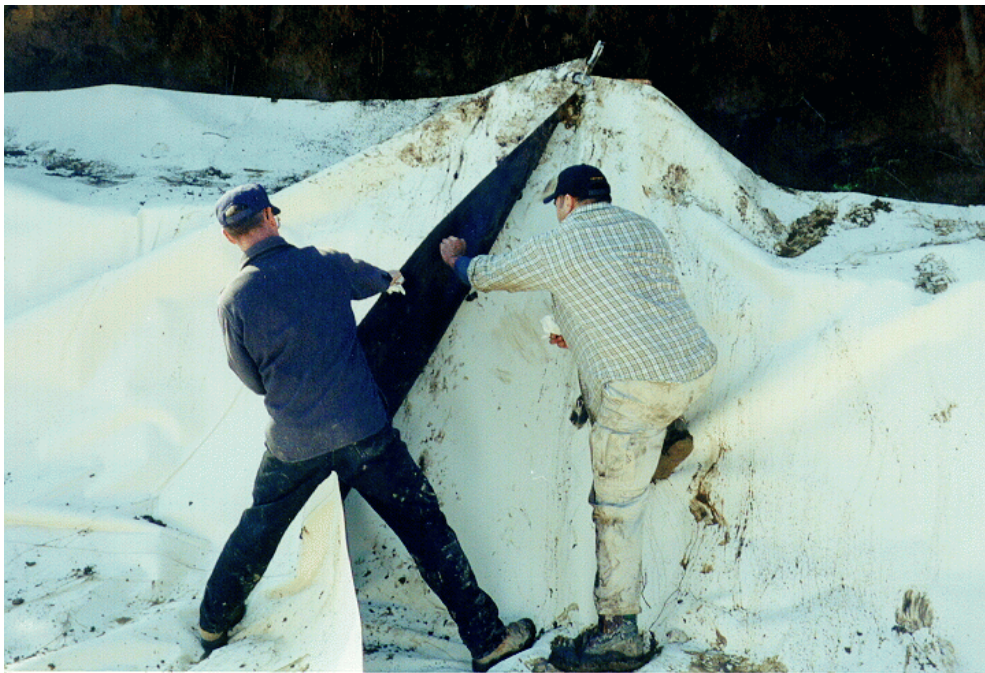
Photograph 14.—Overlapped seams are cleaned to remove dirt and mud before seaming.

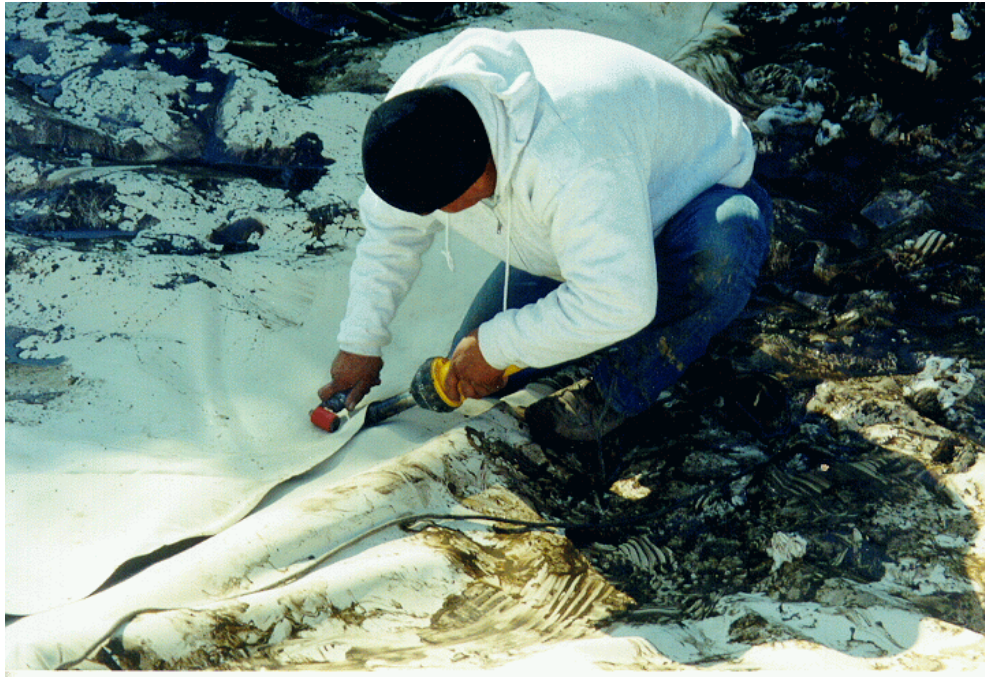
Photograph 15.—Master welder from Serrot uses hot-air welder to seam the Metallocene.

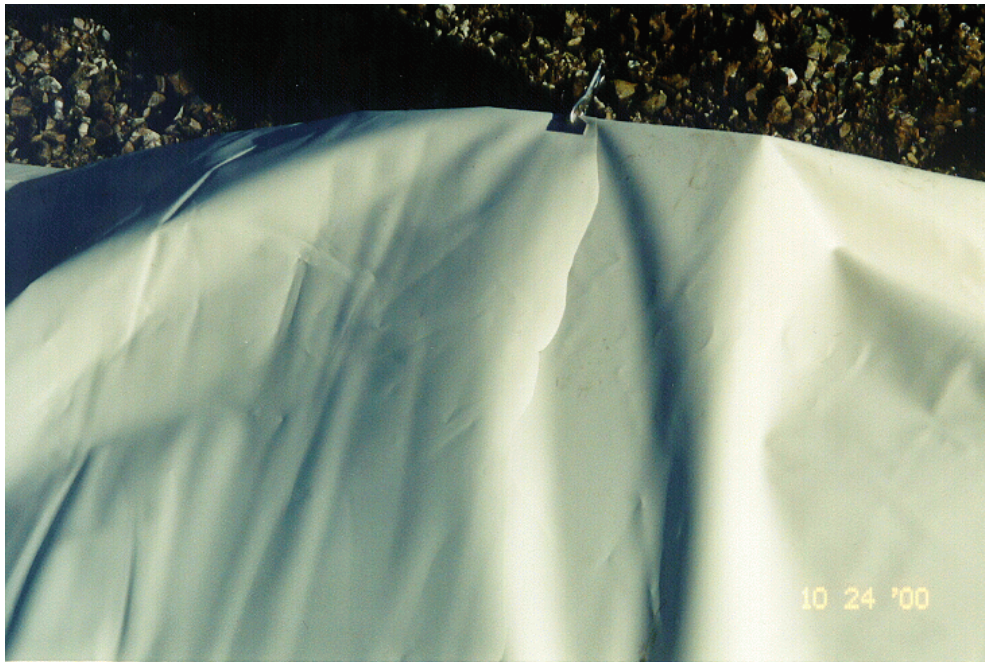
Photograph 16.—Plywood (not visible) is temporarily placed under the liner to provide a firm surface for seaming. Overlapped seams are clamped into final position for seaming.

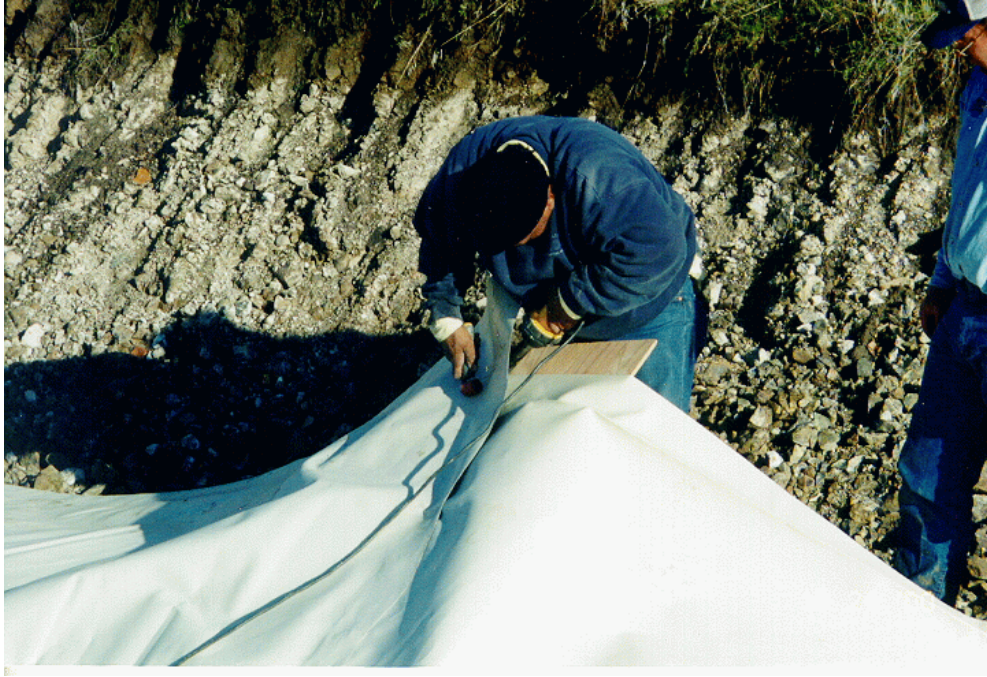
Photograph 17.—As the seaming is completed, the plywood is removed.

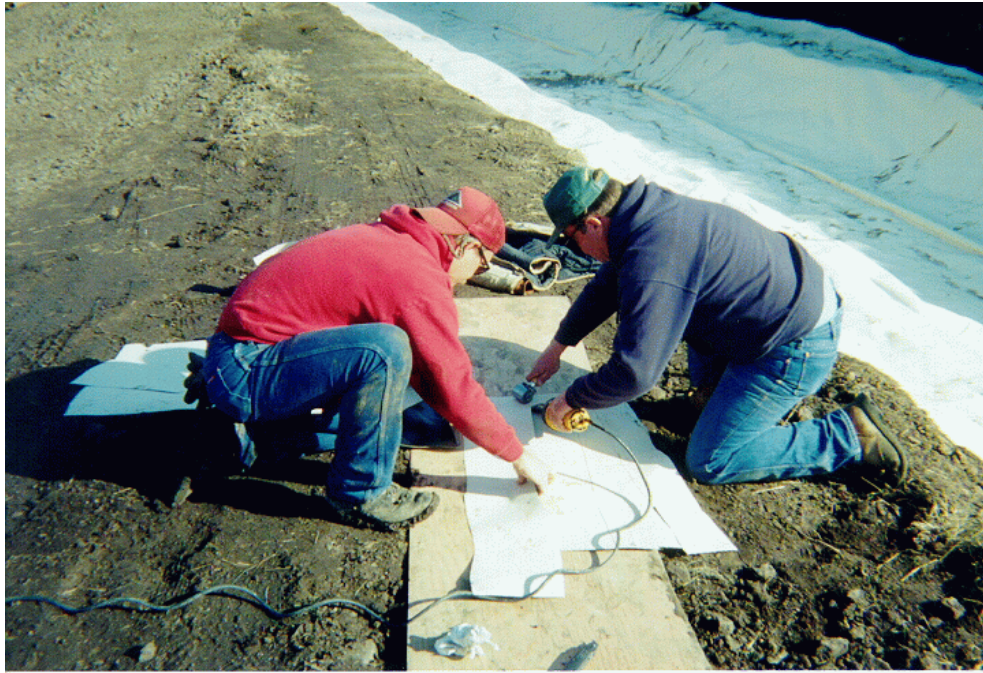
Photograph 19.—Irrigation district personnel are trained in proper seaming techniques for any future repairs.

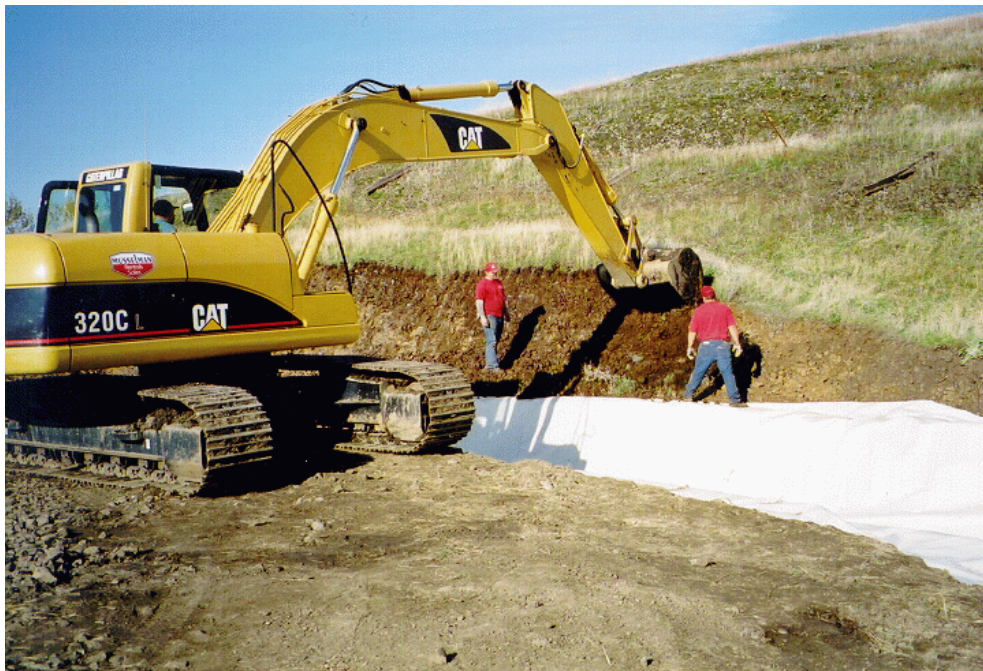
Photograph 20.—Trackhoe places cover material over the far anchor berm.

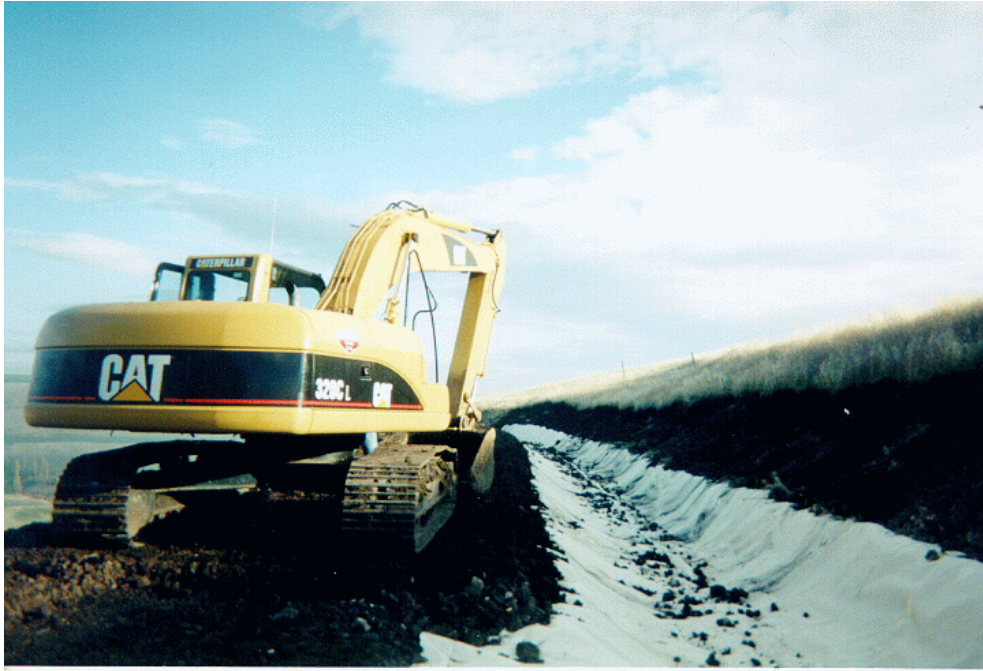
Photograph 21.—Additional road base was imported to restore the access road and to cover the near anchor berm.

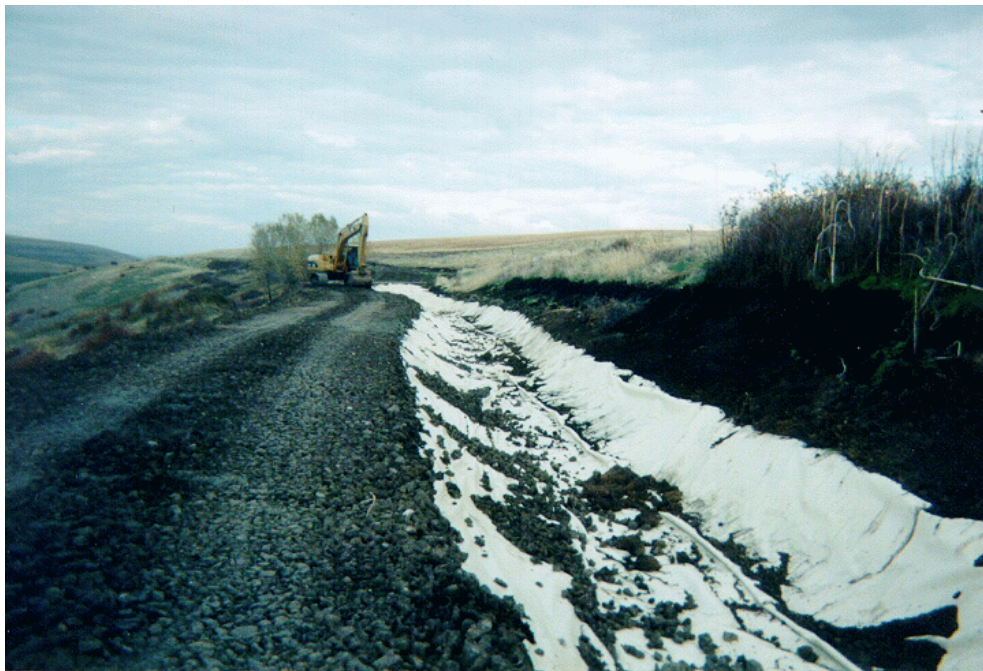
Photograph 22.—Finished Metallocene installation.

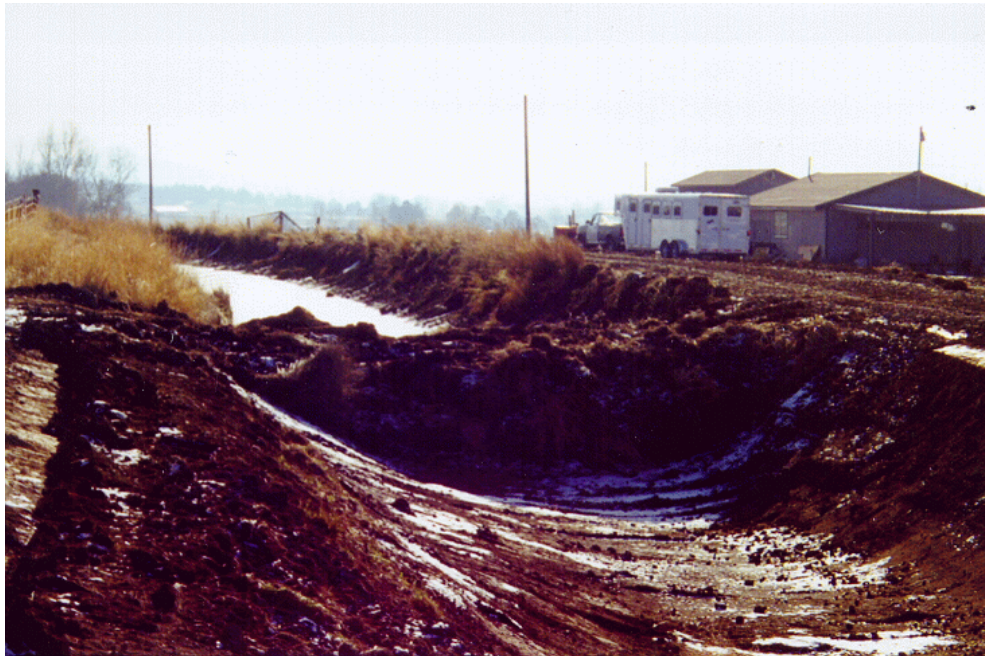
Photograph 1.—Earthen dike at upstream end of the test section. Preconstruction conditions are visible upstream from the dike.
